Seventh Elect Church in Spiritual Israel
7028/7036 9th Avenue NW, Seattle

Historic and Cultural Resources Report

April 2008

The Johnson Partnership
1212 NE 65th Street
Seattle, WA 98115-6724
206-523-1618, www.tjp.us

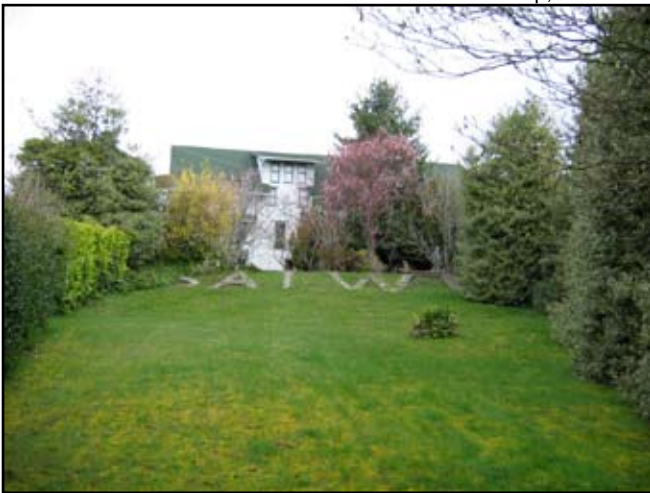
Figure 6 • Viewing to the north from the southwest corner of the subject property

The site measures 100 feet east to west by 365 feet north to south. The property is bounded by 9th Avenue NW on the west and residential properties on the north, east, and south. The ground level slopes to the south approximately 10 feet from the northern property line. The site contains extensive mature landscaping and raised vegetable plots. Hedges ranging in size from six feet to nearly twelve feet high obscure the interior of the property from all sides. Concrete letters six feet tall lying on a berm south of the buildings spell out the name Salwt in capital letters. Several varieties of fruit trees and berry bushes are well established and planted in an orderly manner. On the northern half of the lot is a foundation intended to support a temple that has not been built upon. Its walls and window openings frame views into a formal planting area surrounded by the poured concrete. The western wall of the foundation serves as a wall for a garden shed/greenhouse. *See Figures 6 and 7.*

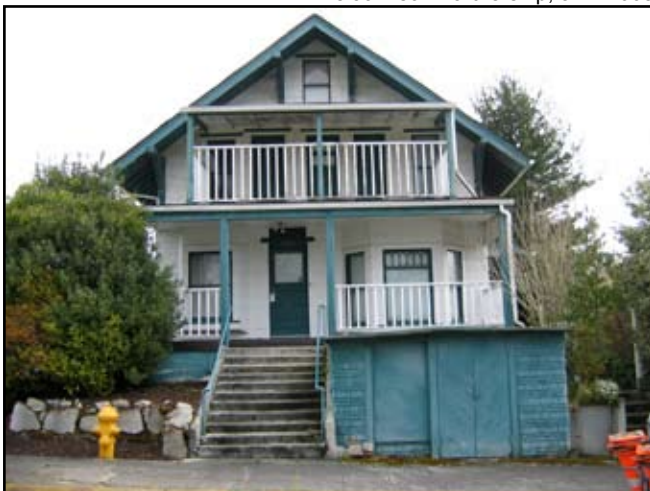
The southern building is a wood-framed, four-story structure clad with asbestos siding, with an attic and full basement. The building measures approximately 75 feet by 25 feet. The western elevation has a concrete stairway north of the centerline of the building leading to a porch on the main floor. A pair of painted, herringbone-patterned, wooden doors are placed in a wooden, shingled exterior wall and open onto the sidewalk on the south side of the elevation, leading to the basement. The main floor of the building contains two bay windows flanking a single-lighted, painted wooden door at the head of the stairs. Four slender columns support a porch roof and upper floor deck. The second floor western façade contains three doors in the middle of the building opening onto a covered porch supported by the main floor's porch roof. A wooden-framed, one-over-one double-hung window flanks the three doors on each side of the façade. A wooden-framed one-over-one double-hung attic window is centered between two brackets in the overhanging peaked gable.

Figure 8 • West façade, church building

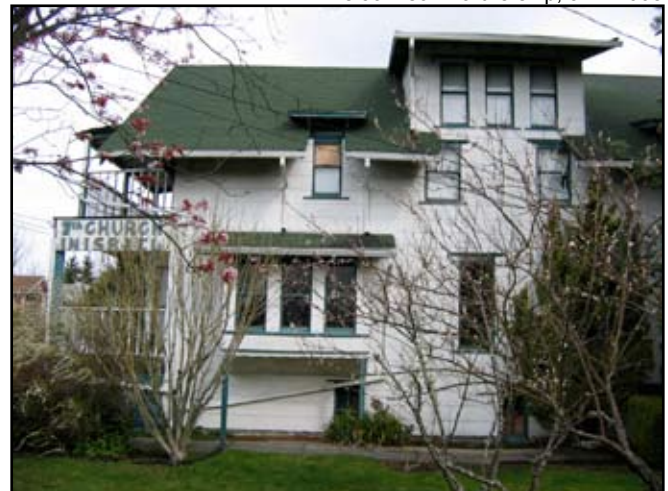
The southern façade of the building is partially obstructed by a large conifer on the eastern end of the building. Four-paned windows allow natural light into the basement. The main floor of this elevation has a bay containing three, one-over-one double-hung windows. Three more double-hung windows are evenly spread over the middle portion of the façade and are hidden by foliage. Two vinyl double-hung windows are placed in the western portion of the main floor's southern façade are

also hidden from view. The upper floor contains original wood, double-hung windows placed in no relation to the windows at other levels of the building. The head of the windows on this façade is at the same height as the intersection of the roof and the exterior walls. Small, flat dormers allow the placement of a short horizontal light above the roof and the windows on the second floor. A large flat attic dormer contains three double-hung windows in the same plane as the windows below.

Figure 9 • Partial south façade, church building

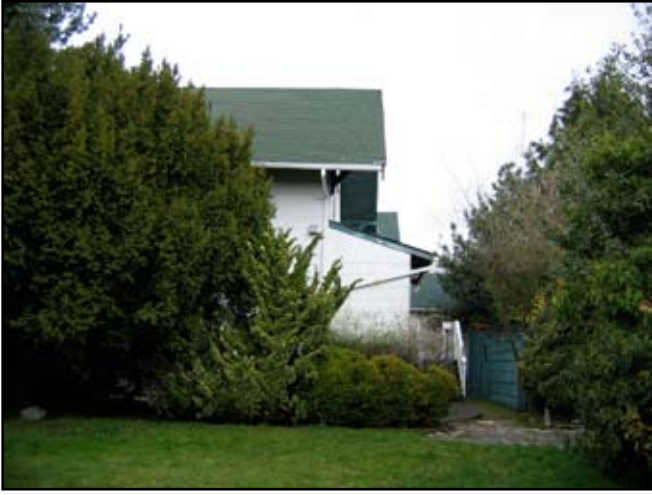
The eastern elevation of the building contains a pair of shed additions, one of which contains a door to the main level and the other a covered stair to the basement. A double hung window is centered in the gable of the second floor.

Figure 10 • Partial south façade, eastern end, church building

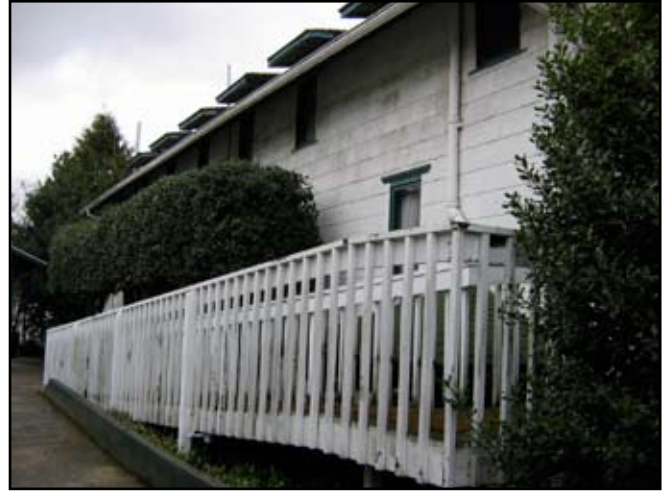
The northern façade is obscured by a row of manicured holly bushes and contains a similar window pattern to the southern elevation. This façade lacks the bay window on the main floor and the large attic dormer of the southern façade. The windows on all three levels do not relate to windows on the other floors. *See Figures 8 – 14.*

Figure 11 • Partial north façade, church building

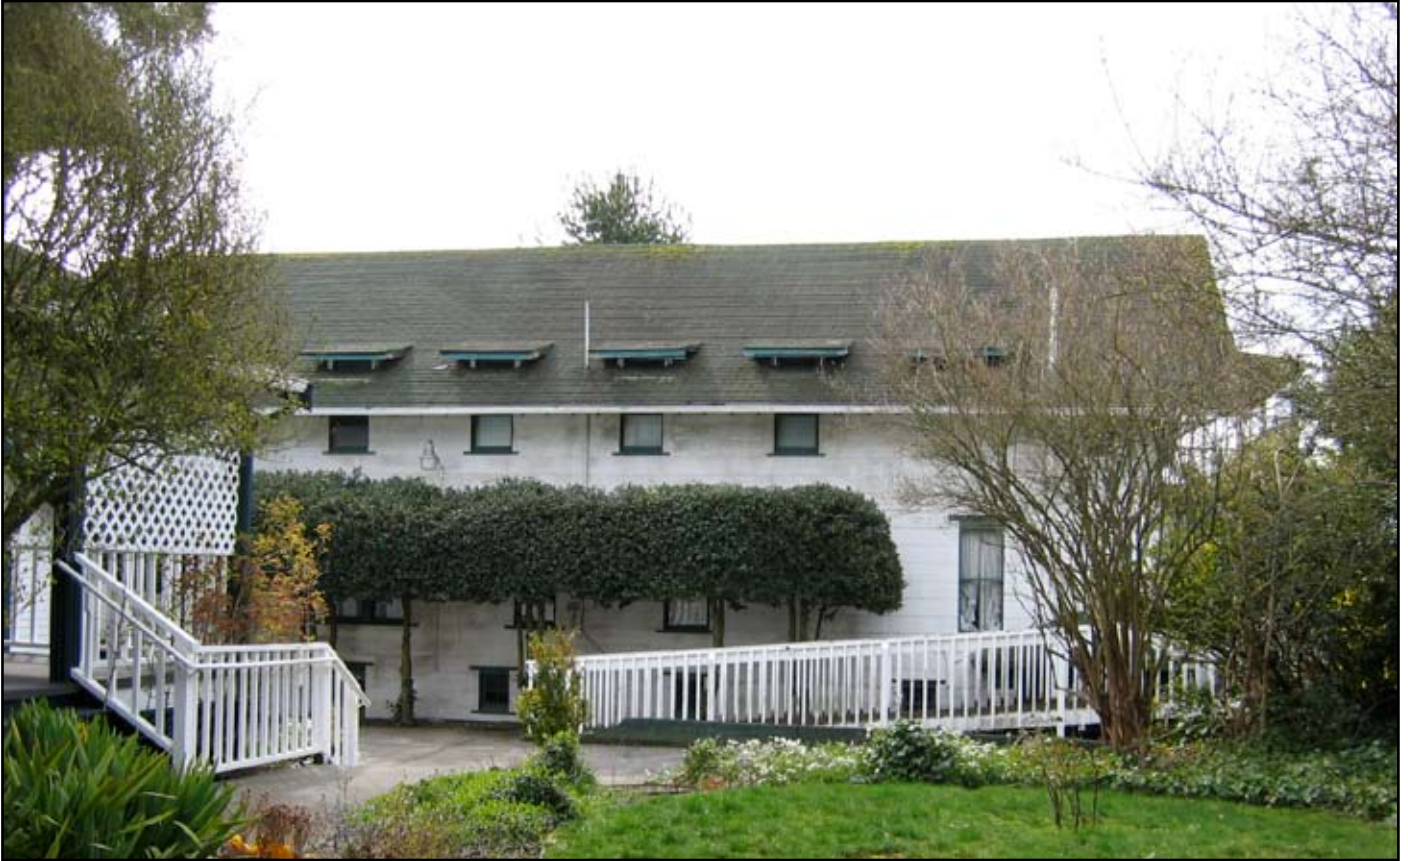
Figure 12 • Partial north façade, church building

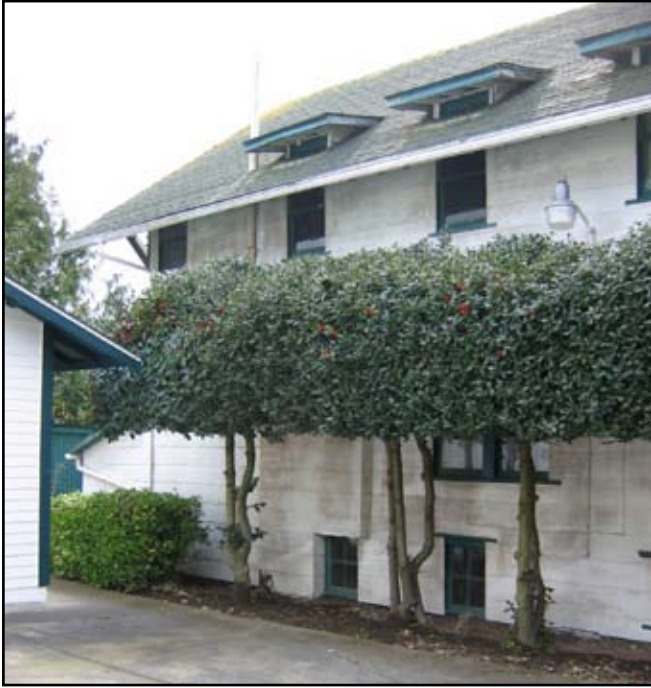
Figure 13 • Partial north facade, church building, east end

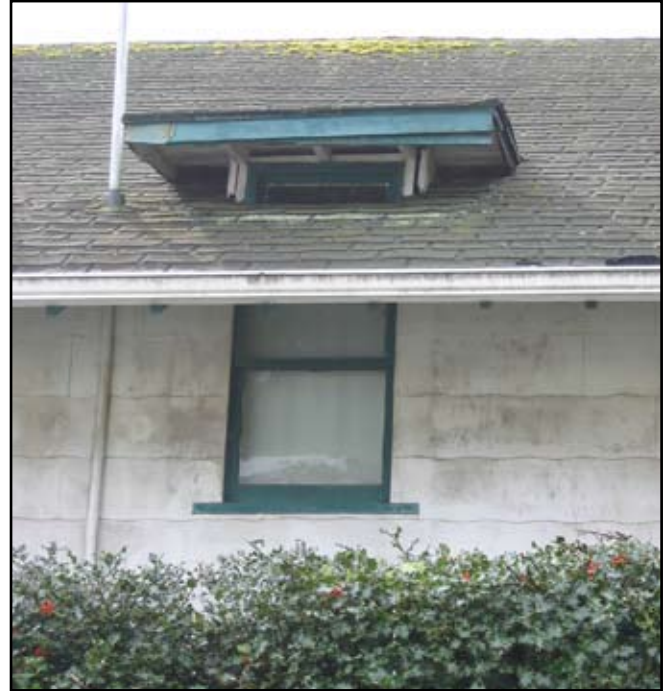
Figure 14 • North facade, window detail

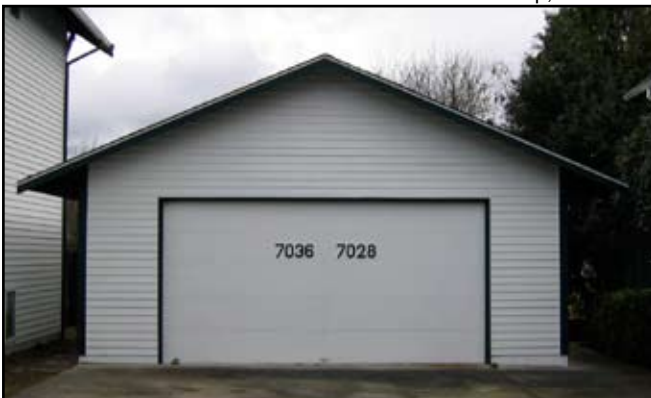
A 24-foot by 26-foot single-level, vinyl-sided garage is placed approximately eight feet north of the church building. The garage has an overhead door centered on the west side of the building and a 30-inch wide door in the eastern half of the south façade. A large window is placed east of the door in the south façade and a similar window is centered in the east façade. The north elevation is blank. *See Figure 15.*

Figure 15 • Garage, west facade

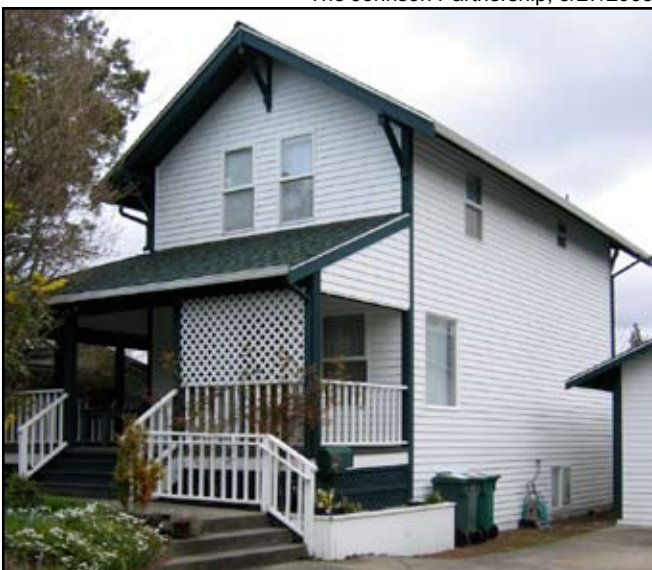
The western façade contains a central stair leading to a porch. A wooden entrance door is placed asymmetrically in the western wall and next to a vinyl-clad, double-hung window. The recessed façade contains a single door under the northern porch roof. The western gable on the second floor has two double-hung windows roughly centered in the façade.

The southern façade contains a slider window at the basement level. A large fixed window is on the west edge of the main floor, and a smaller, double-hung window is further east on the second floor.

Figure 16 • Partial west and south facades, residence

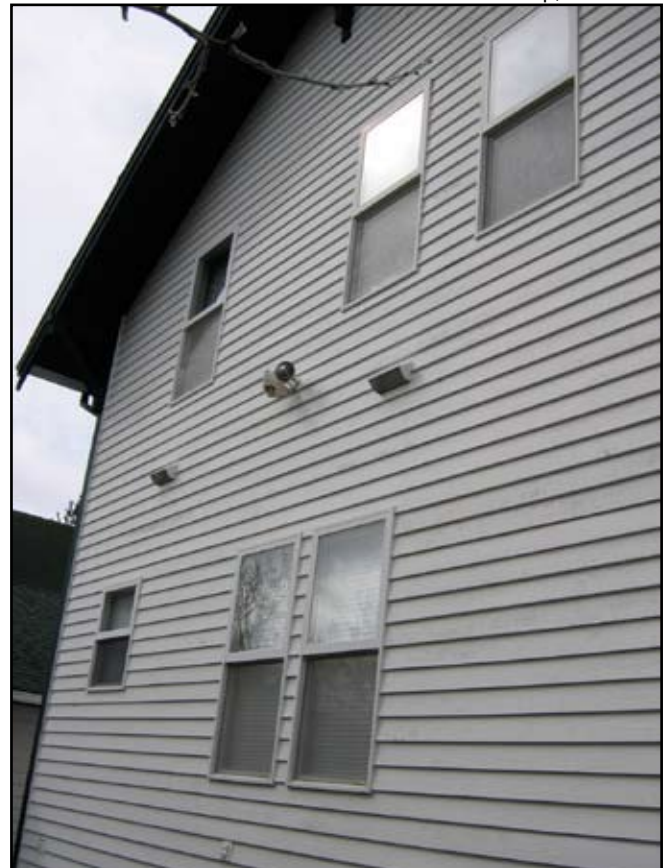
The eastern façade contains a casement window on the basement level. A small double-hung window is located near the southern edge of the building, and a pair of larger double-hung windows is roughly centered in the first floor level of the building. The second level of the building has three unequally spaced double-hung windows.

Figure 17 • Partial east facade, residence

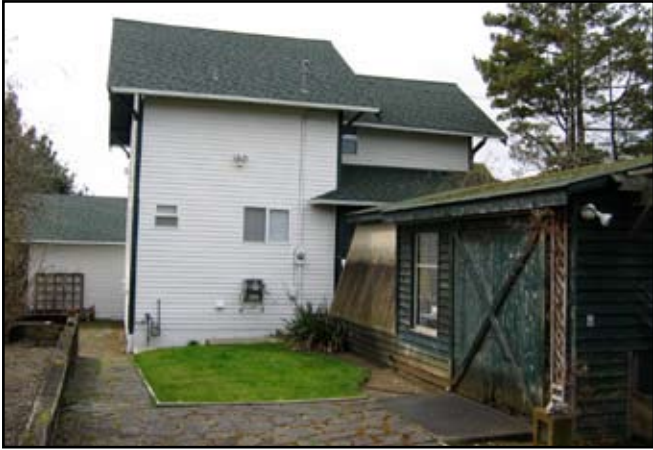
The northernmost northern façade contains two windows, a small double-hung and a larger slider, both on the main level. The recessed façade contains a pair of double-hung windows under the porch roof and centered in the wall. A small, single double-hung window has been placed above the northern porch roof in this façade. *See Figures 16 – 19.*

Figure 18 • Partial north facades, residence and garage beyond. East facade, garden shed

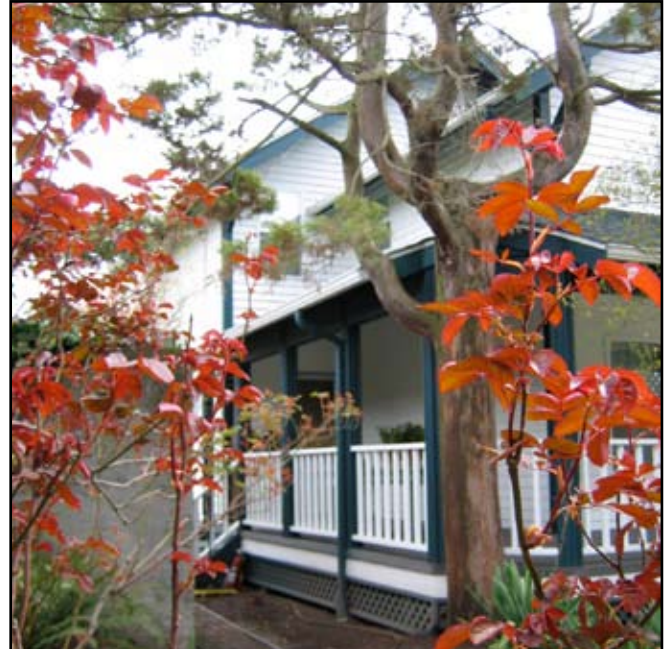
Figure 19 • Partial north and west facades, residence

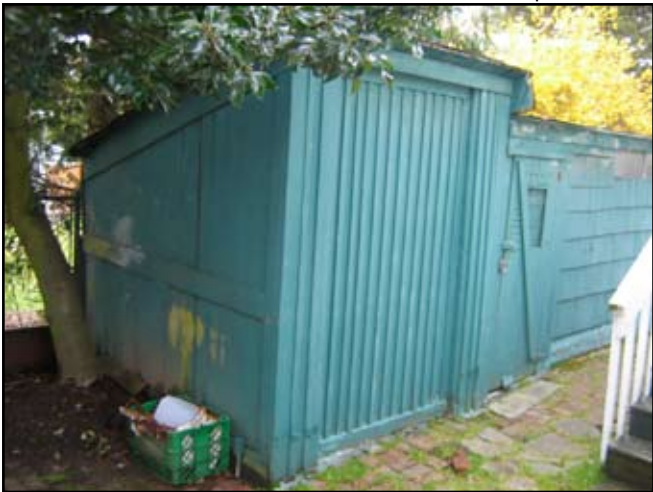
An 8-foot by 34-foot wood-framed and wood-shingled, single-story woodshed is located east of the church building. A simple shed roof slopes to the east. *See Figure 20.*

Figure 20 • Wood shed, north and partial west facades

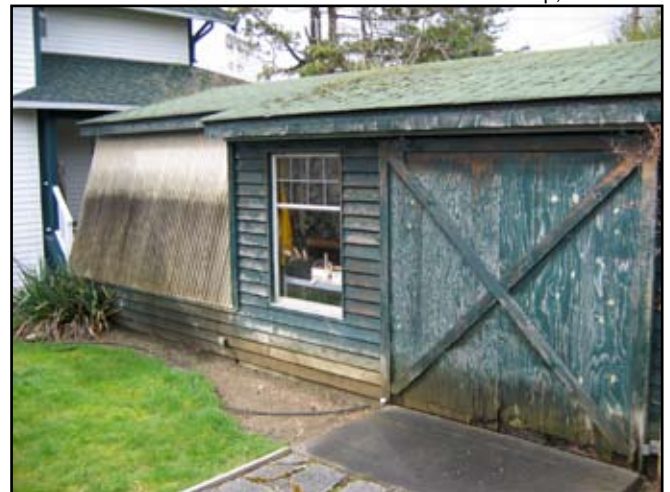
An approximately 8-foot by 20-foot wood-framed shed and greenhouse is attached to an unfinished foundation project. *See Figure 21.*

Figure 21 • Garden shed, east facade

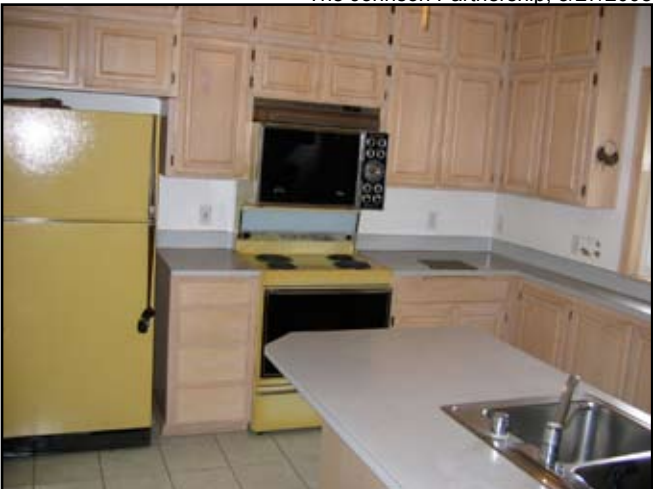
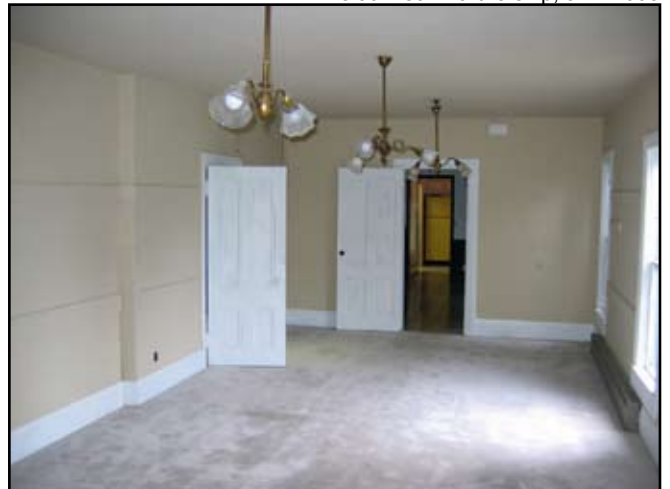
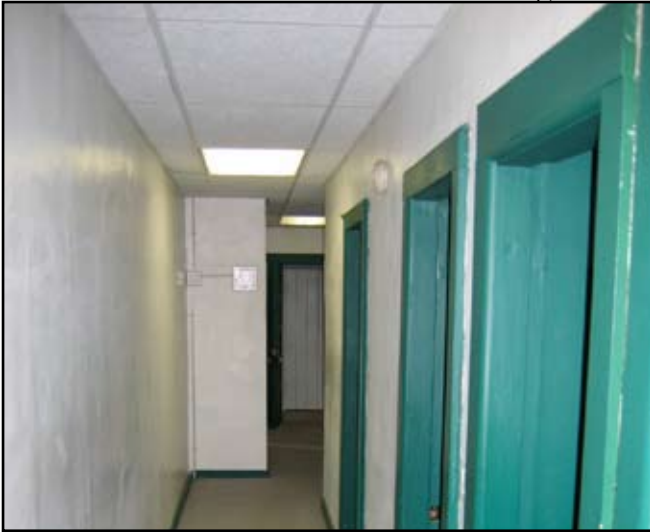
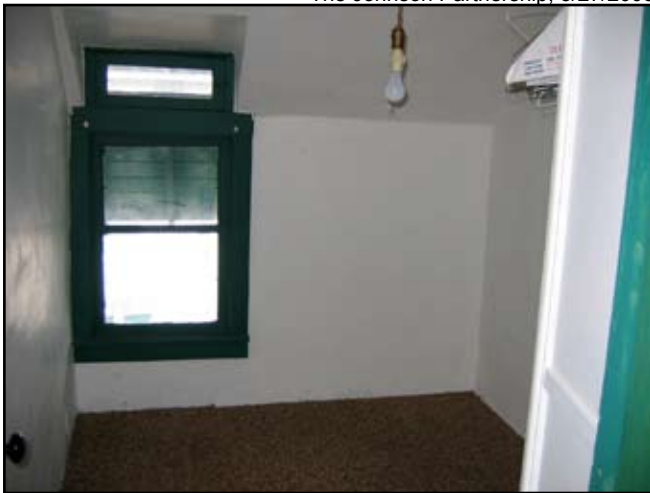
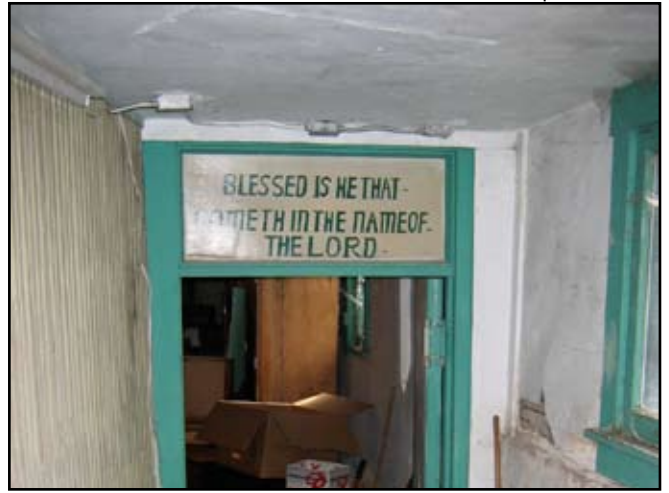
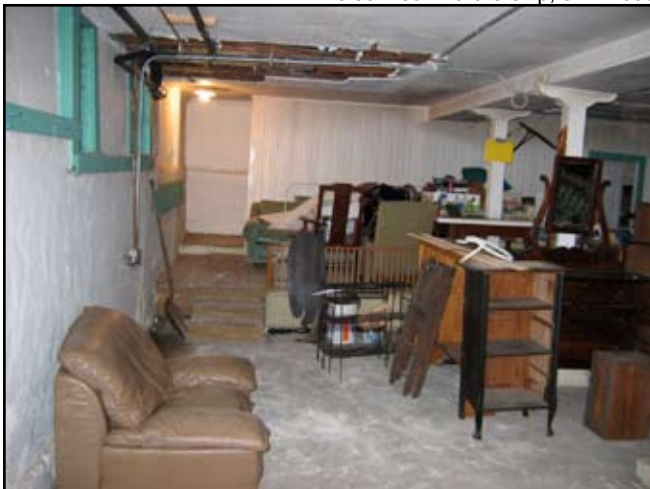
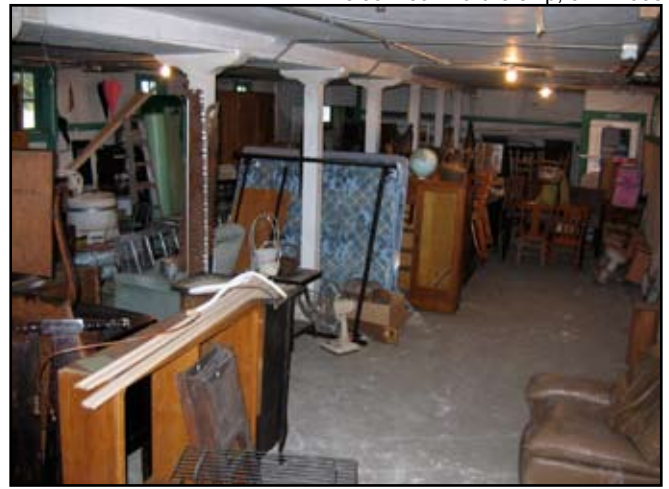
The interior of the building contains several small bedrooms on the main floor, a large gathering room, a smaller dining room and a kitchen. Two stairs at either end of the building provide circulation to the floor above. The second floor is composed entirely of small bedrooms off a central hallway. The attic space was not accessible. The basement contains a large open area with columns dividing the space into north and south halves. This space was held church services and other group functions. A raised platform on the east end of the building has a railing and a table built around a column. A table/lectern has been built around the easternmost column, near the edge of the raised platform. Male and female powder rooms are located in the northwest corner of the basement. The main floor has a pair of bathrooms on the north side of the building, and the upper floor also has a pair of bathrooms. *See Figures 22 – 29.*

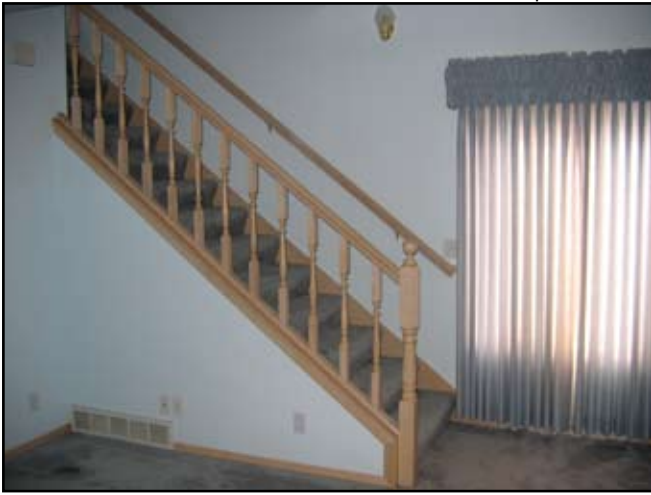
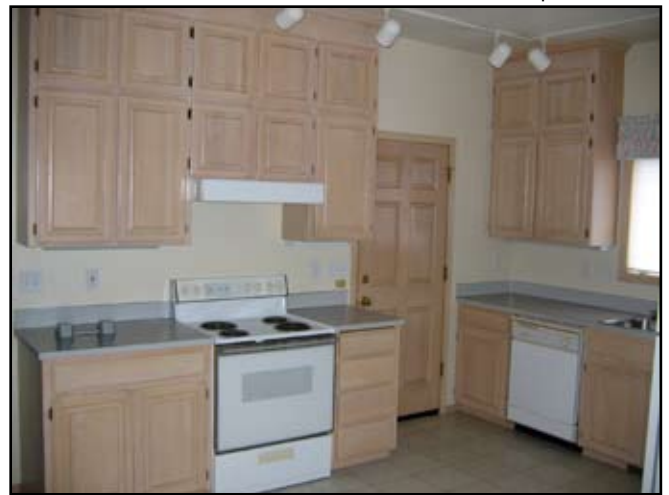
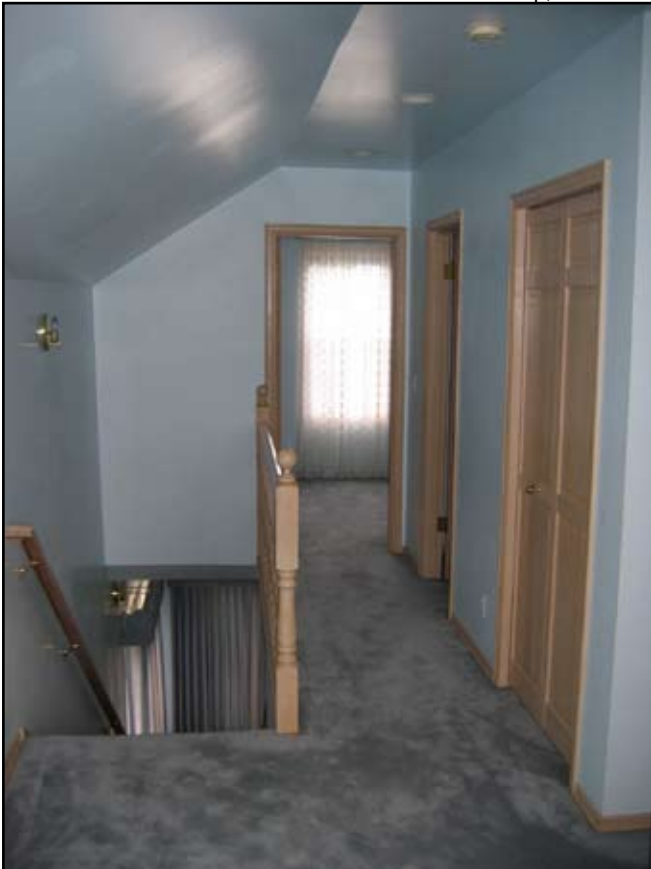
The interior of the residence was completely remodeled in 1992. The building contains a living room, kitchen, bathroom, and utility room on the first floor. Stairways to the basement and upper floor are stacked on the southern wall of the building. The upper floor of the building contains two bedrooms and a larger bathroom. The basement is unfinished concrete, poured in 1992. *See Figures 30 - 33.*

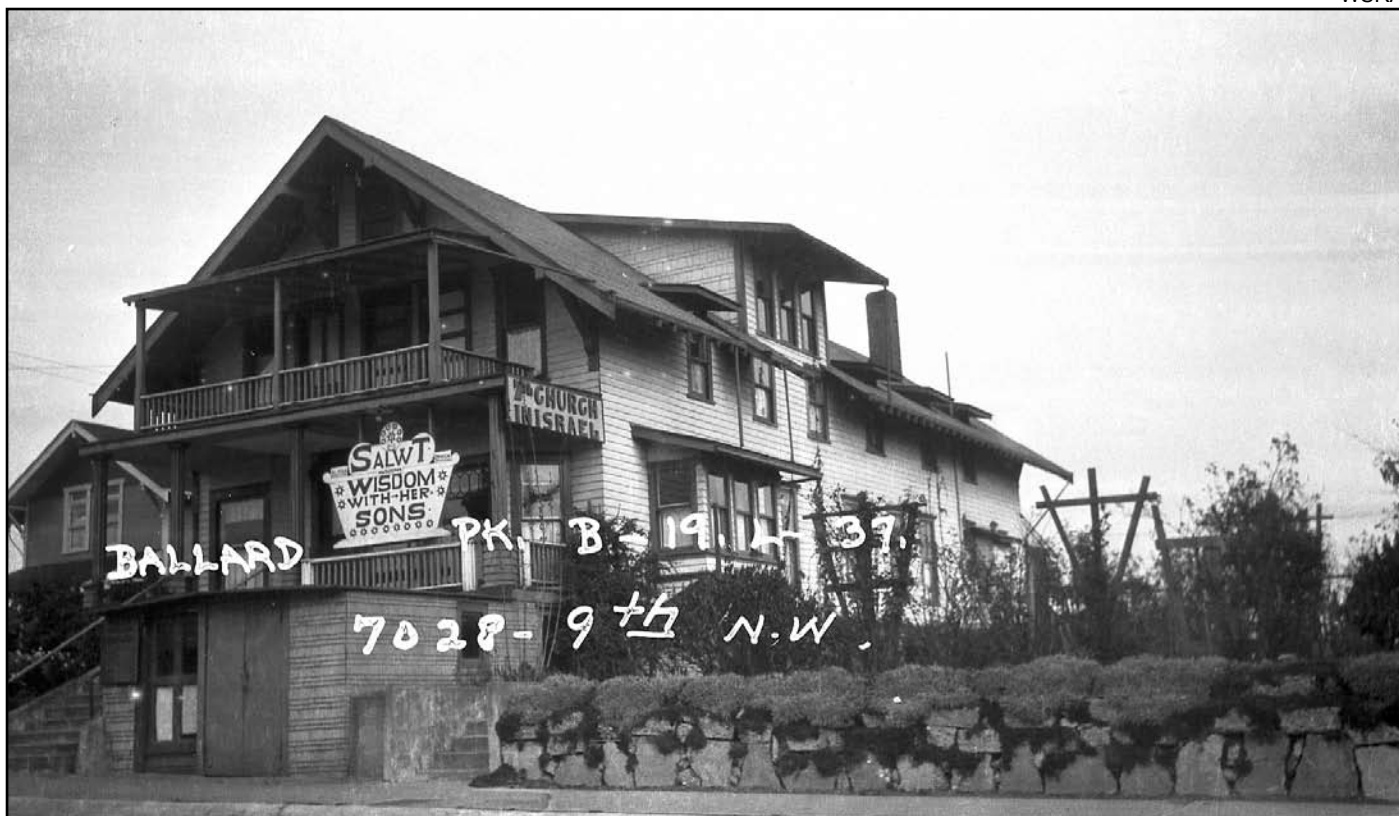
Both of the larger structures exhibit brackets and a loose similarity to craftsman or bungalow homes. However, even when the buildings were originally constructed or located on the site, the buildings were not exceptional examples of this type of building and should be classified as vernacular designs, like the outbuildings. *See Figures 35 – 38.*

Figure 35 • West and South façades, church building, 1937

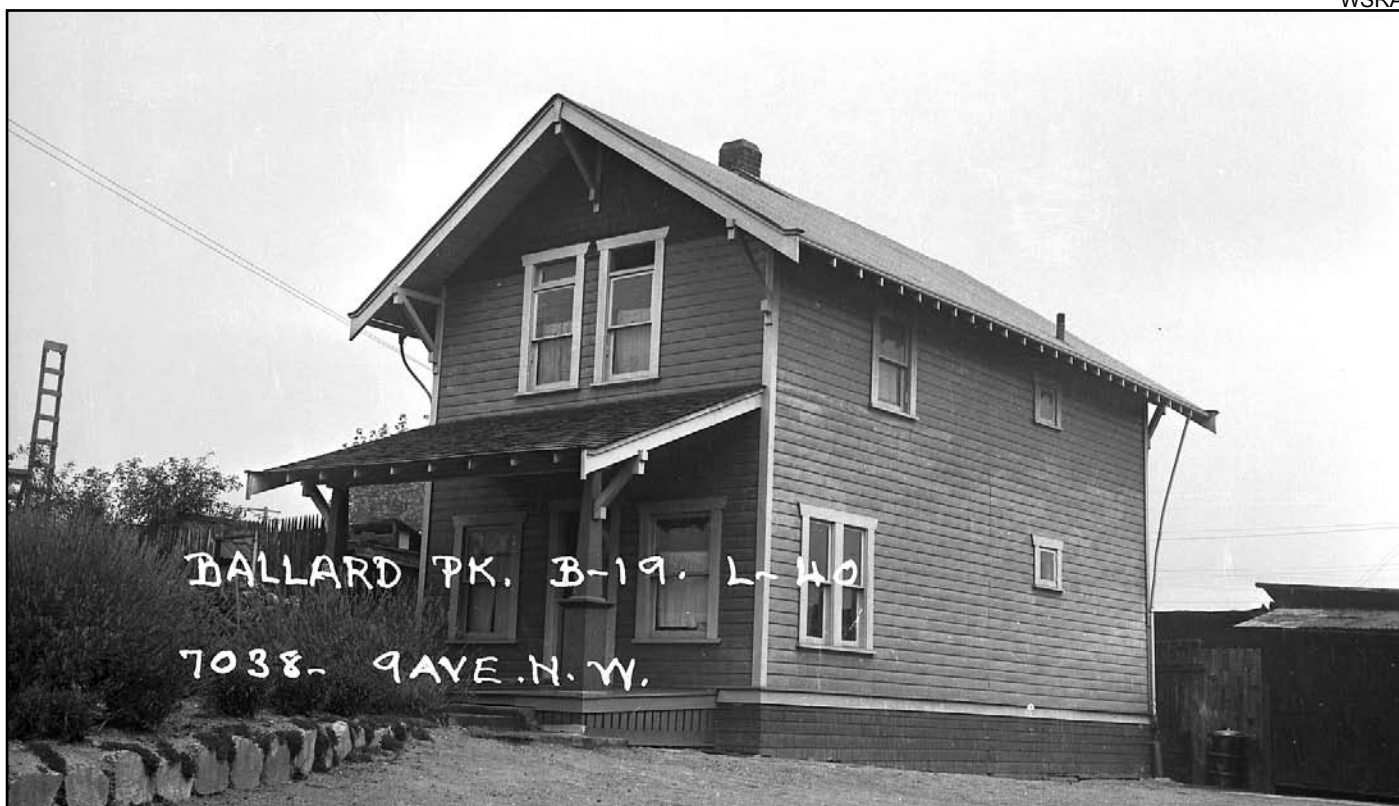
Figure 36 • West and South façades, residence, 1937
